Report

Serious incidents on **18 March** and **8 April 2010**
at **Paris Charles de Gaulle Airport (95)**
to the **Boeing 747-400s**
registered **HS-TGL** and **B-HOV**
operated respectively by
Thai Airways International Ltd.
and by **Cathay Pacific Airways Ltd.**

BEA

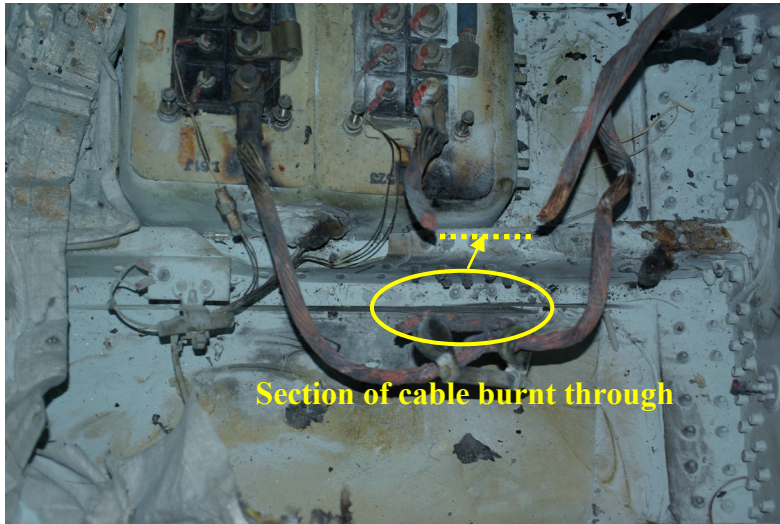
Avionics compartment electrical

In the avionics compartment, the two cables connecting the neutral to the structure of the aircraft were severely damaged and partially melted. One of them was burnt through in two places by the heat. The insulation blankets were burnt in the area surrounding the electrical connectors. The avionics compartment was filled with dry chemicals from the extinguisher.

In this area, the structure of the aircraft's fuselage was subjected to significant heating (800 °C) that required major repair work before the aircraft could be returned to service.

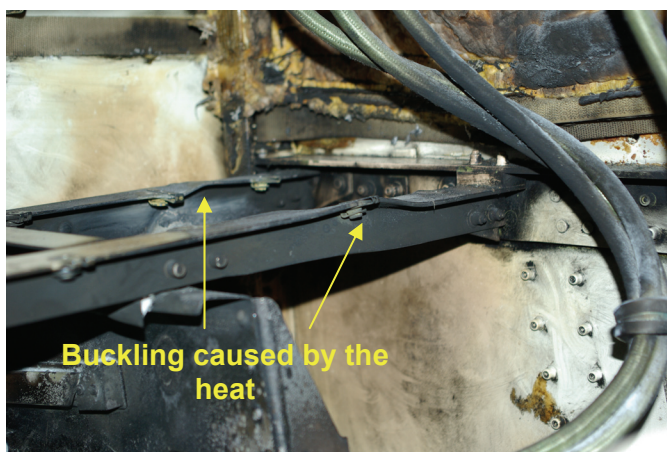
In the avionics compartment, the cables linking the neutral to the aircraft structure were partially melted, but not burnt through. The insulation blankets were burnt in the area surrounding the electrical connectors. In the avionics compartment, a little of the dry chemicals from the extinguisher was present around the connectors though in smaller quantity than in the case of the event involving HS-TGL. The outer connectors showed signs of heating, and bore traces of dry chemicals from the extinguisher.

The overheating caused by the fire led to a deformation of the aircraft fuselage structure. Major repair work also had to be undertaken before the aircraft could be returned to service.

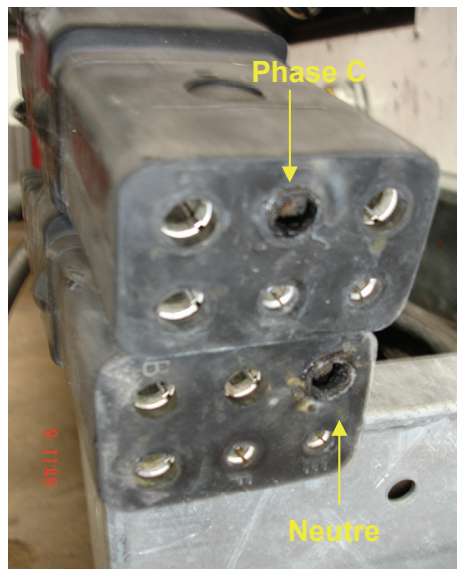
After the incident, the GPU was immediately taken out of service. The electrical cables between the GPU and the aircraft showed significant signs of heating that led to a reduction in their cross section. The elastomer boxes that surround the contacts also showed signs of heating on the neutral on one plug and on the phase C on the other.

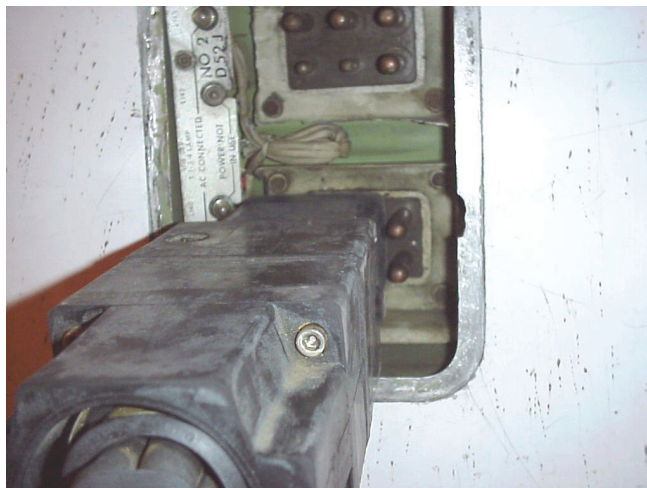
Observation of the damage showed that in all of these cases the phase C had been connected directly to the neutral.

An internal Boeing study, undertaken in 2002, showed that the composite material guide, which ensured positioning of the ground power receptacles, could be damaged. In this situation, it is possible to align the plugs incorrectly. At the time, Boeing had not identified the problem as having any effect on safety.

Example of incorrect connection (Boeing source)

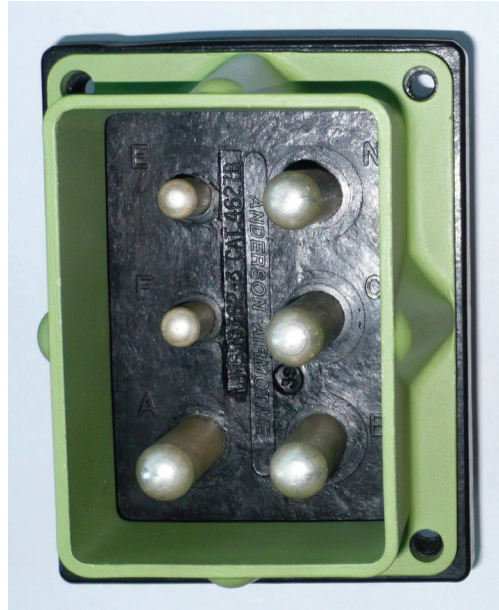
Following the first event reported to Boeing in 2001, an NTO was supplied to the operator concerned to install the guide from the B767 (Ref. MS.17845-1) in place of the part initially installed on the B747-400 (Ref. 66-9236). The replacement part ensures precise guidance. It is made of metal and is much more robust. It has been installed as a production part on the B747-400 since 2003.

According to Boeing, no cases of incorrect alignment have been reported to them on aeroplanes equipped with the MS17845-1 guide.

- **EASA and the FAA make mandatory the replacement of the original parts, with the reference 66-9236, by parts with the reference MS17845-1 on all versions of B747 aeroplanes.**

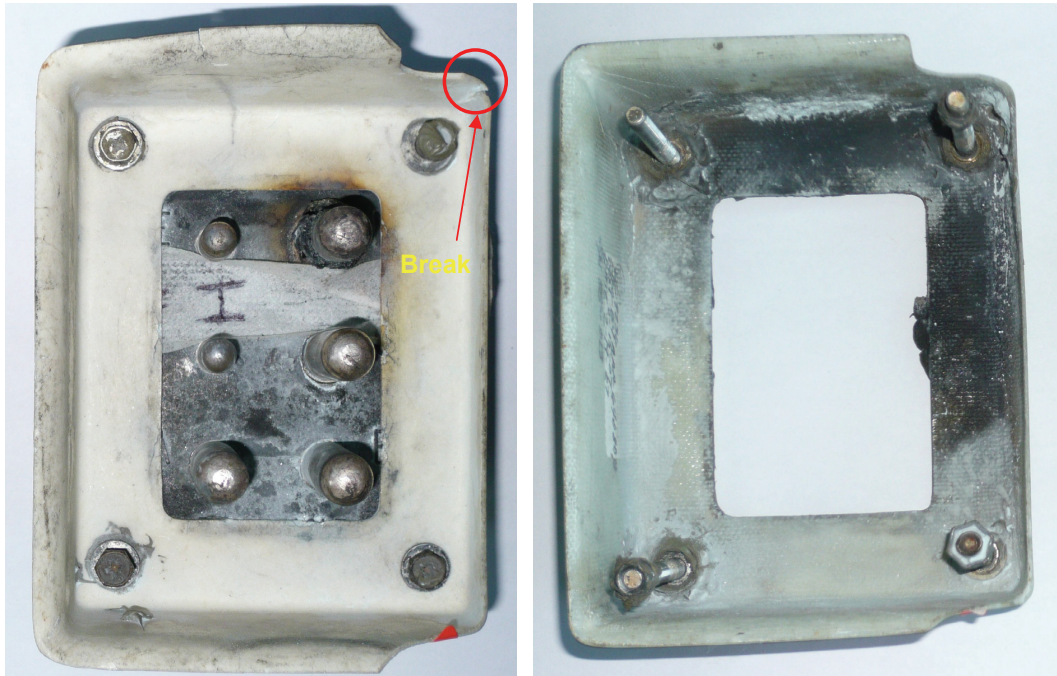
Guides from B-HOV

Following the serious incidents to HS-TGL and B-HOV, some tests were performed in cooperation with Cathay Pacific Airways and one of the GPU maintenance companies. The original guides from B-HOV were removed. One of them was broken.

- ❑ Ground technicians using the GPU receive limited training and have limited technical knowledge of the aeroplane's electrical system.
- ❑ On B-HOV, the guide made of composite materials on connector No1 was broken.

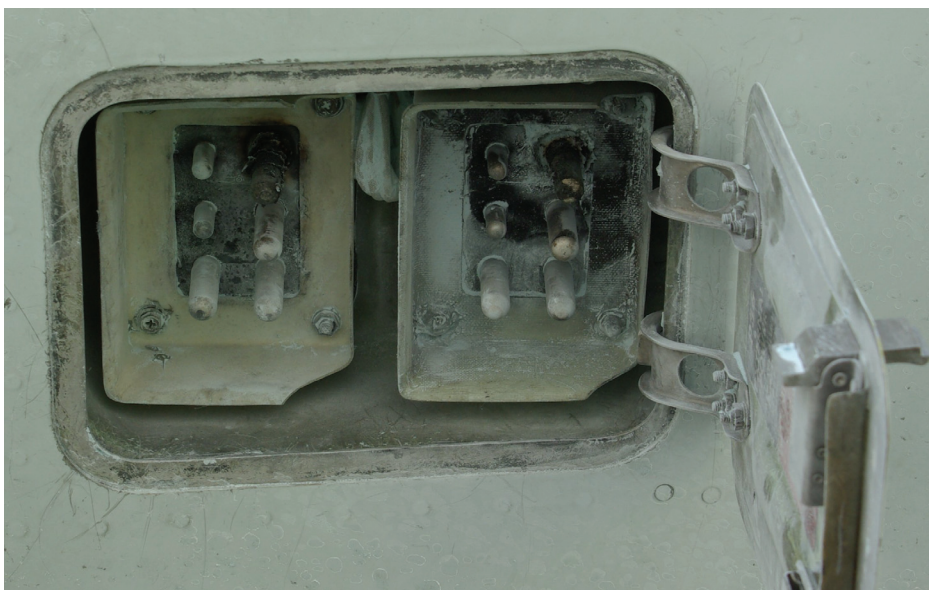
Observation of the burn marks on the external connectors on B-HOV indicate that the electrical connector plugged into connector No2 (on the right in the photo below) was incorrectly positioned. The connector guide was not broken. It was not possible to determine which electrical connector was incorrectly positioned on the HS-TGL.

Electrical connectors from B-HOV a short time after the incident

- ❑ On B-HOV one of the electrical connectors was correctly lined up on connector No1 while the second was misaligned on connector No2. On circuit No2 the phase C supplied by the GPU was directly linked to the aeroplane's neutral.

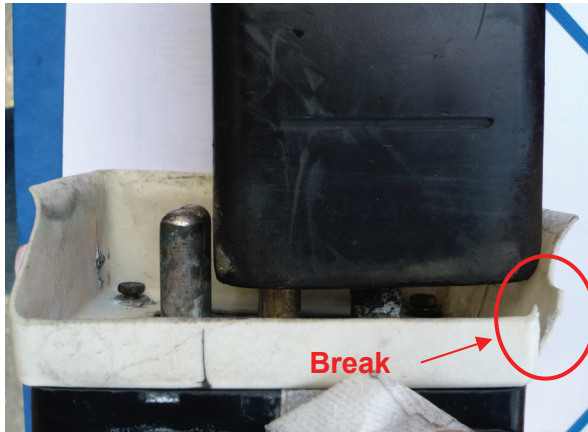
With the original guide, broken, incorrect connection is easy. Engagement was incomplete but contact was established:

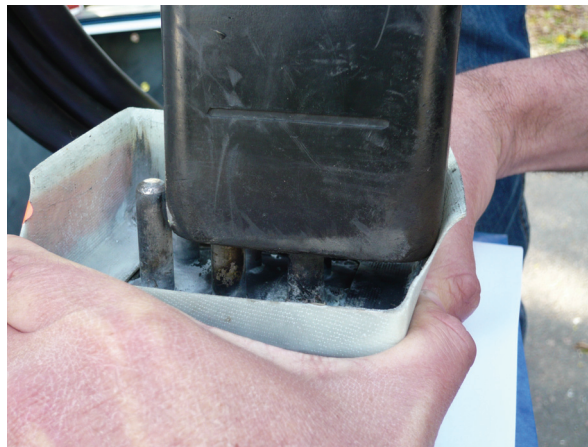
With the original guide, unbroken, incorrect connection was also possible even if it needed slight force. Engagement was not complete but contact was established.

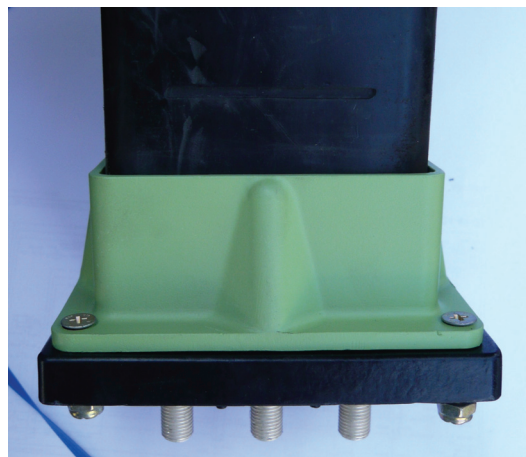
With the MS17845-1 metal guide, incorrect alignment of the electrical connector was impossible:
